NASA CR-66840

METEOROID PENETRATION DETECTOR DEVELOPMENT PROGRAM

FINAL SUMMARY REPORT  
VOLUME I

Prepared under Contract No. NAS1-7043 by  
MARTIN MARIETTA CORPORATION  
Denver, Colorado

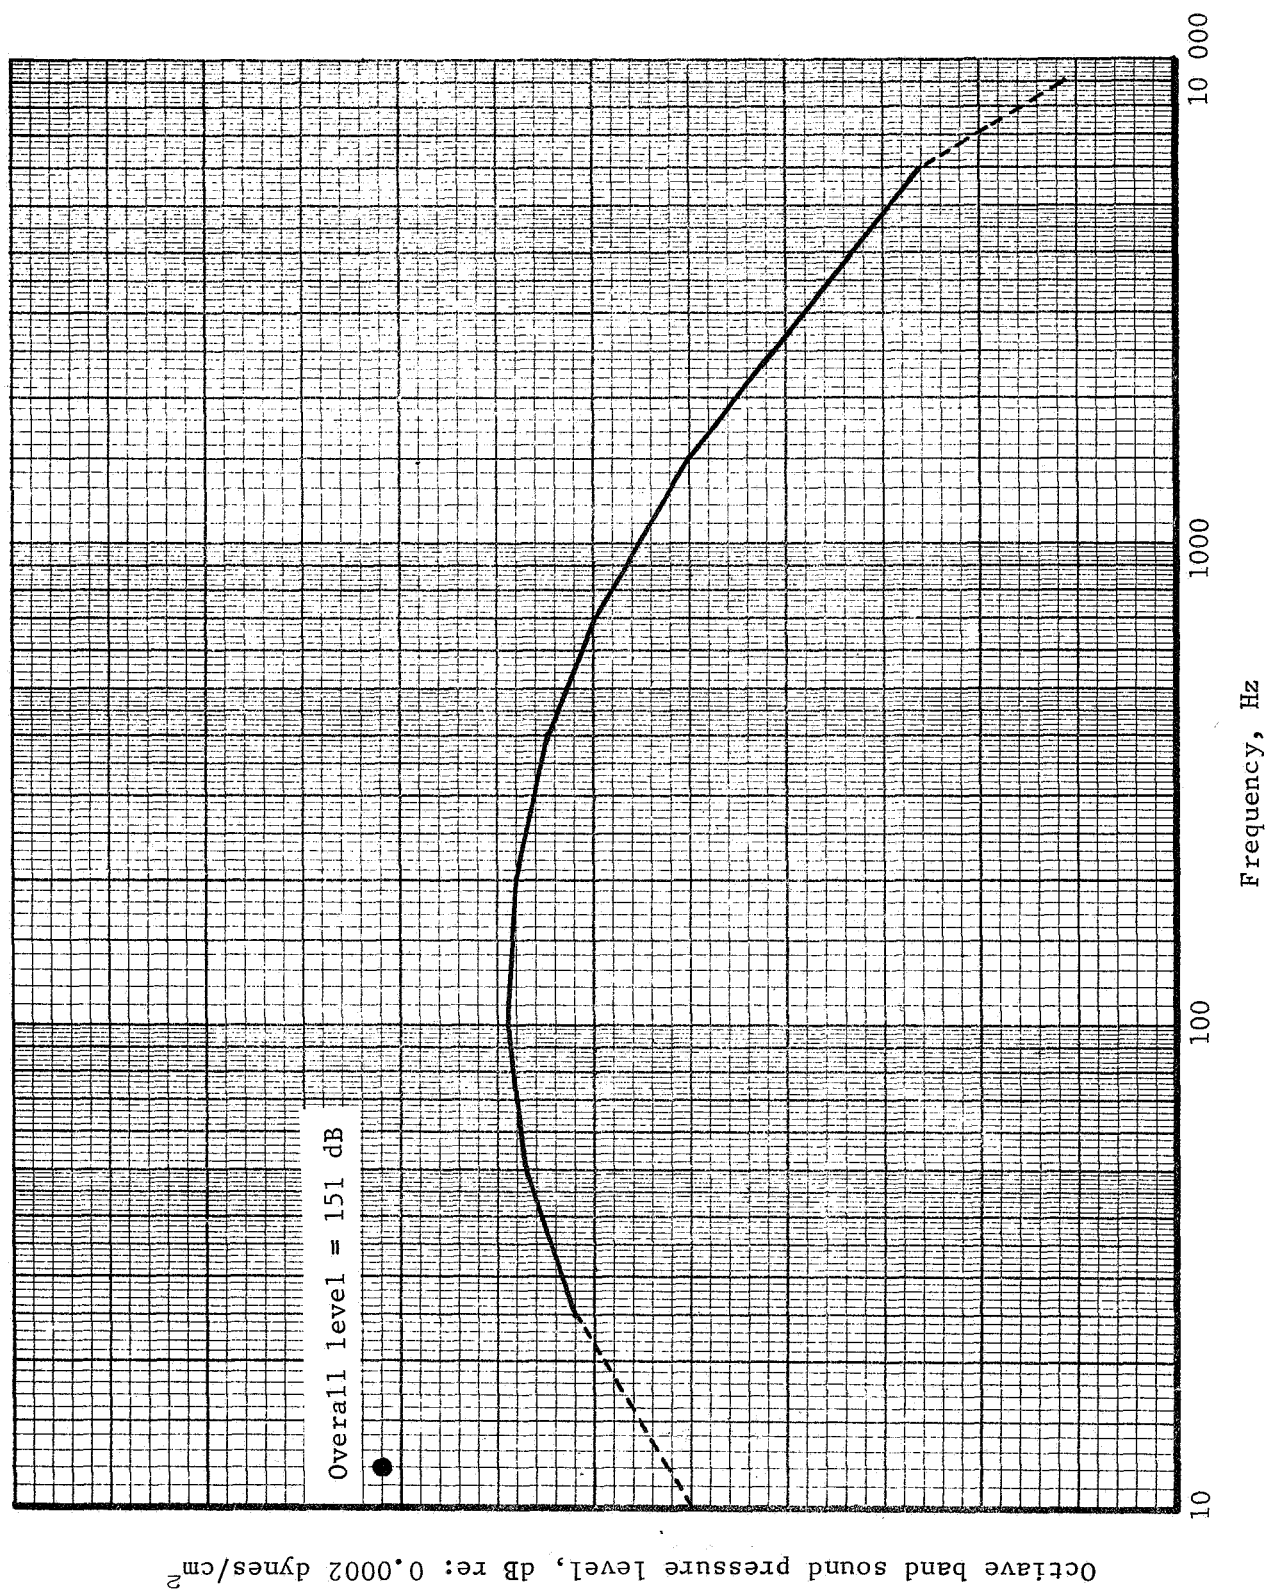
Figure 119.- Acoustic Test Spectrum, Pressure Switch Qualification

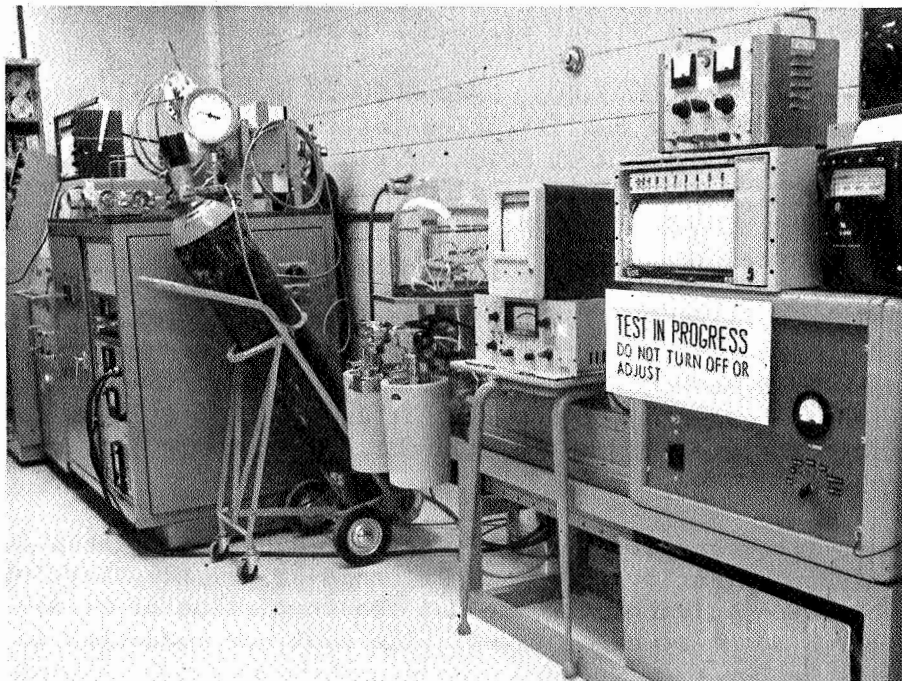
Figure 121.- Overall Test Setup, Pressure Switch Thermal Vacuum Soak

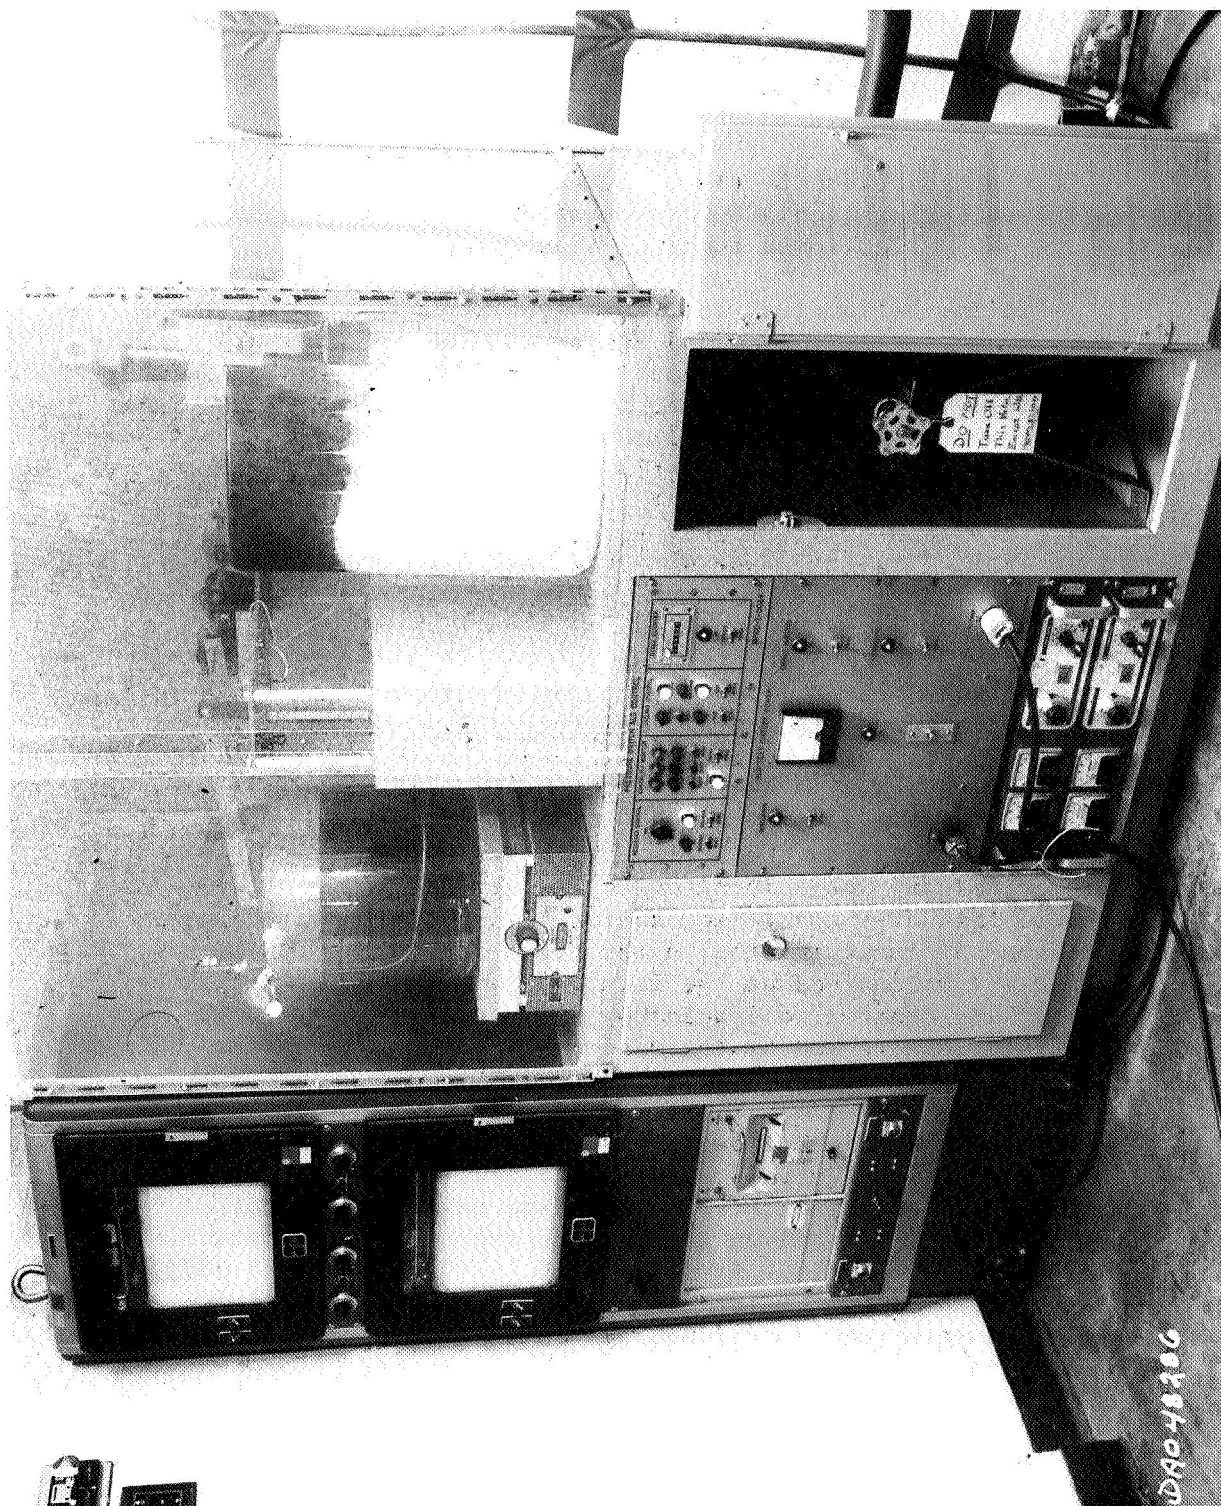
Figure 122.- Overall Test Setup, Pressure Switch ALC Test

In accelerated life cycling the specimens were mechanically attached to a rotating arm and electrically connected to the monitoring circuits of the pressure switch ALC tool (see figs. 122, 123, and 124). They were then cycled 21 344 times between  $+325^{\circ}\text{F} \pm 10^{\circ}\text{F}$  and  $-90^{\circ}\text{F} \pm 10^{\circ}\text{F}$ . The high temperature was obtained by immersing the units into a bath of USP 98.5% pure glycerine that was maintained at the required temperature by a thermostatically controlled heater. The cold temperature was obtained by immersing the units into a bath of ethyl alcohol which was maintained at the required temperature by a thermostatically controlled liquid CO<sub>2</sub> injector. The cycle rate was initially controlled by the readout of a thermocouple imbedded into the center of mass of a "dummy" instrumented pressure switch (see fig. 125), which was also attached to the rotating arm. After sufficient data were obtained to firmly establish the cycle rate required to allow the test specimens to "see" the specified temperatures, cycle rate was then controlled by a synchronous motor-driven timer. The cycle time was established at 7.5 minutes/cycle. At 3000, 6000, 9000, 12 000, 15 000, 18 000, and 21 344 cycles, the test items were removed from the ALC test setup and functional and leak tests performed.

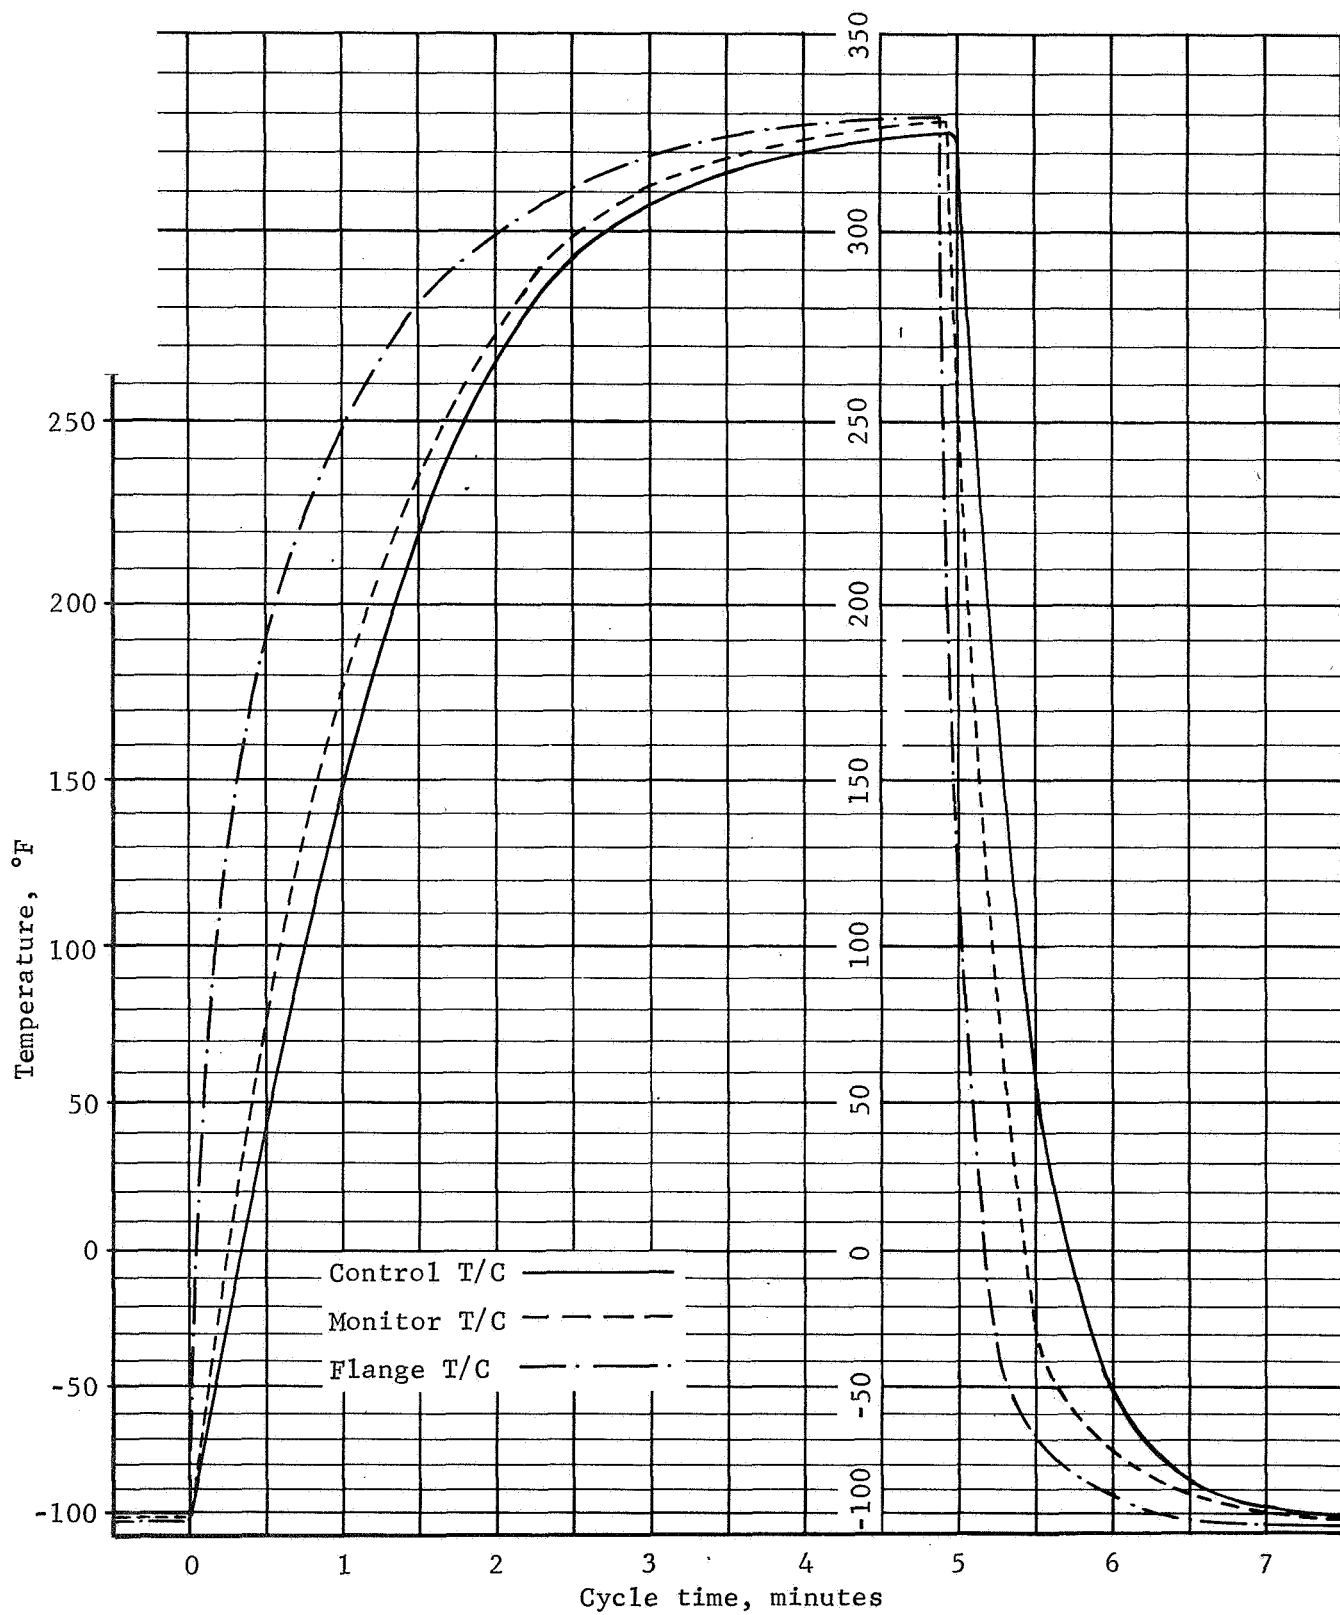
Figure 126.- Typical Temperature Cycle, Pressure Switch ALC

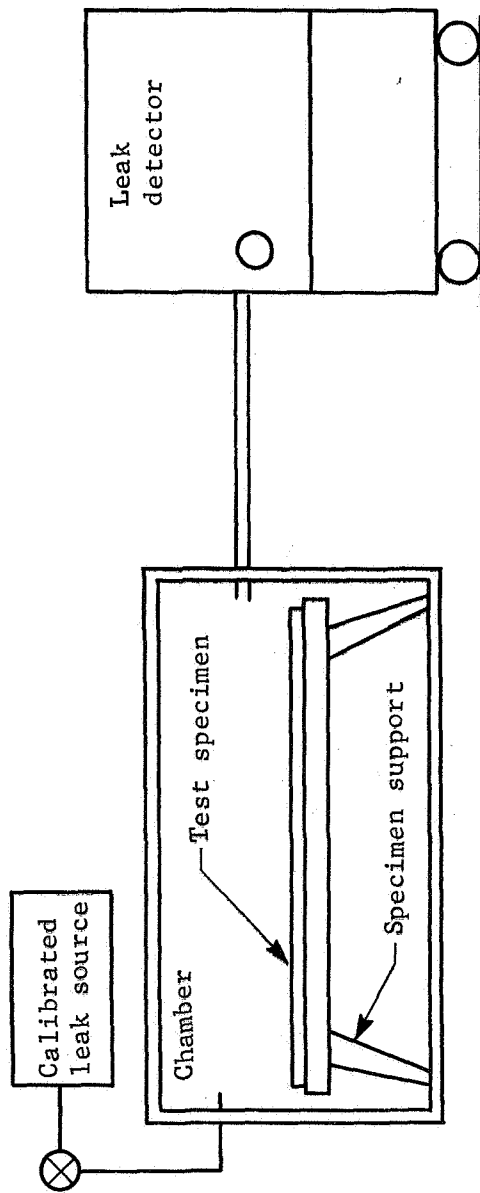
Figure 127.- Leak Test Setup, Helium

For the helium leak test each specimen was placed in a vacuum chamber (see figs. 108 and 127) in which the pressure was reduced to  $1 \times 10^{-5}$  torr, or less, pressurized to  $27.4 \pm 0.5$  psia, and leakage sensed at the normally exposed surface of the specimen. The maximum allowable leak rate was determined by the test specimen volume (see RGA leak). The test was conducted after proof pressure, after dynamics, and after thermal cycling on the D3A, E1A, E3A, and F1A specimens. For the B1A, C1, and D2A specimens, the test was conducted after dynamics and after thermal cycling. The initial leak test for the B1A, C1, and D2A items was an RGA leak test (see below).

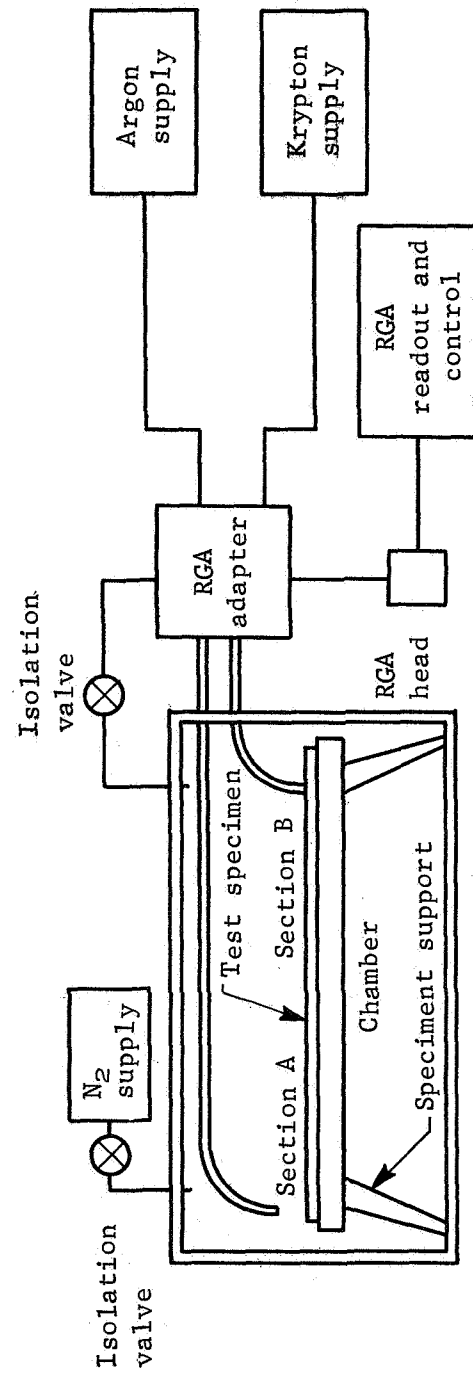
Figure 128.- Leak Test Setup, RGA

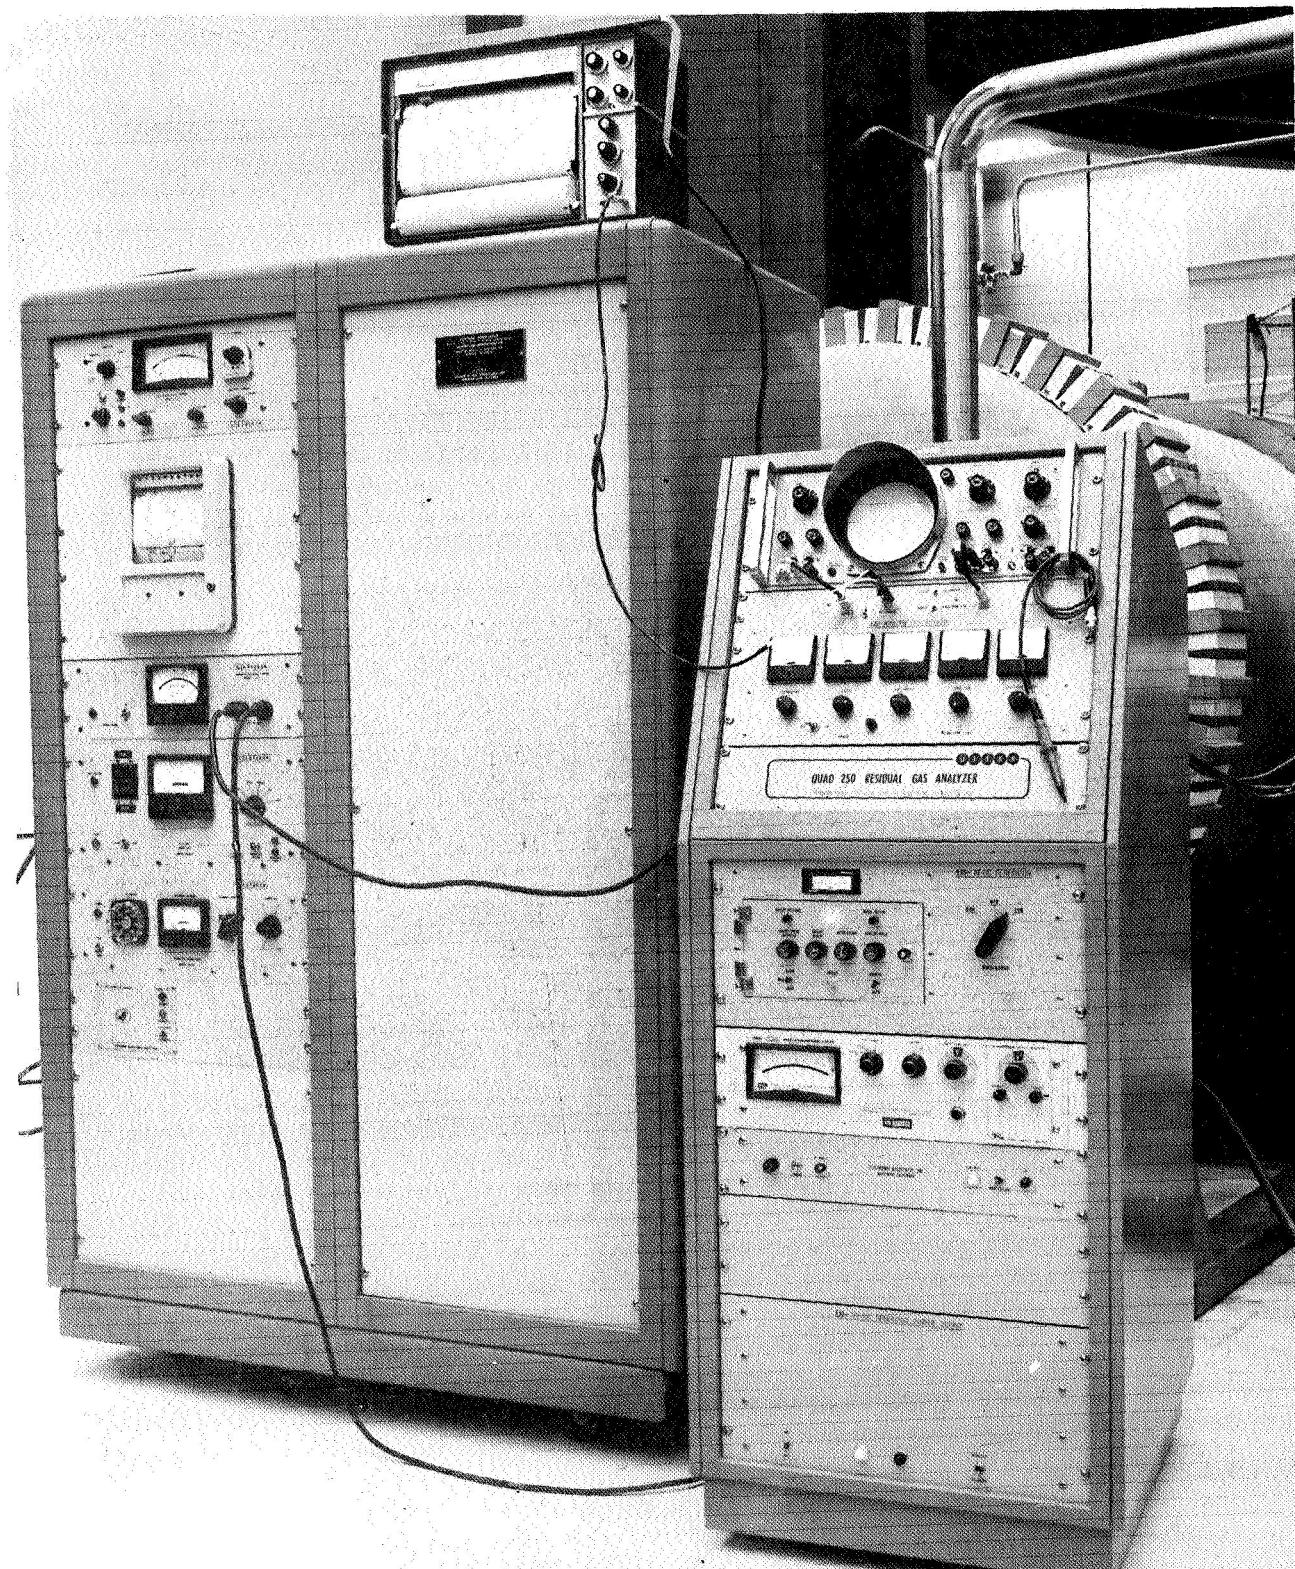
Figure 129.- Photo of RGA Leak Test Setup

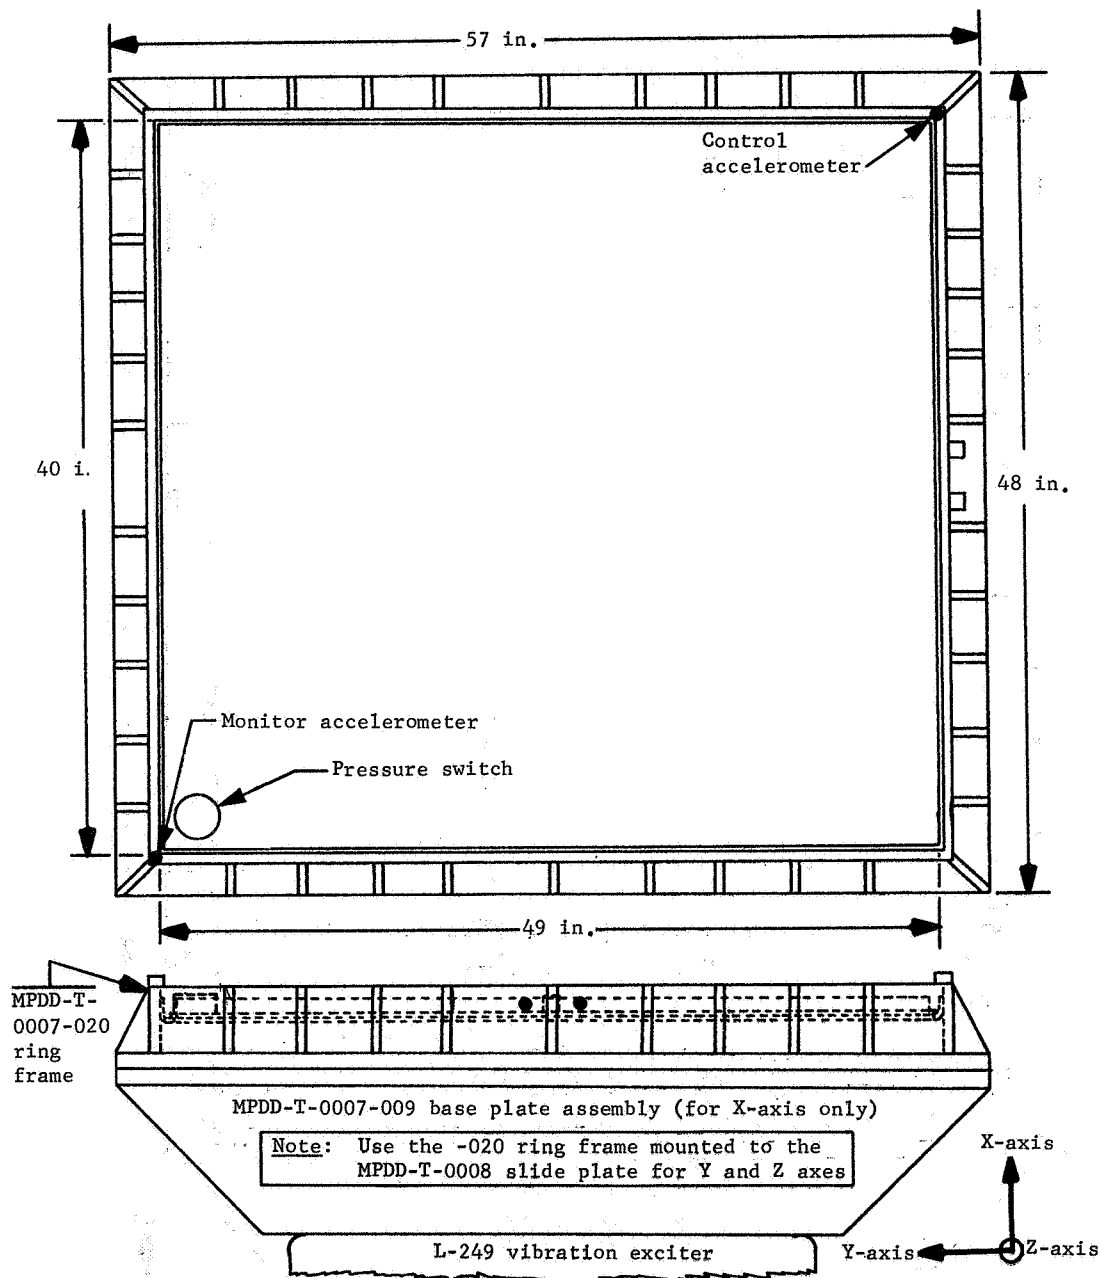
Figure 130.- Vibration Test Setup, 40x49-in. Detector, FAT

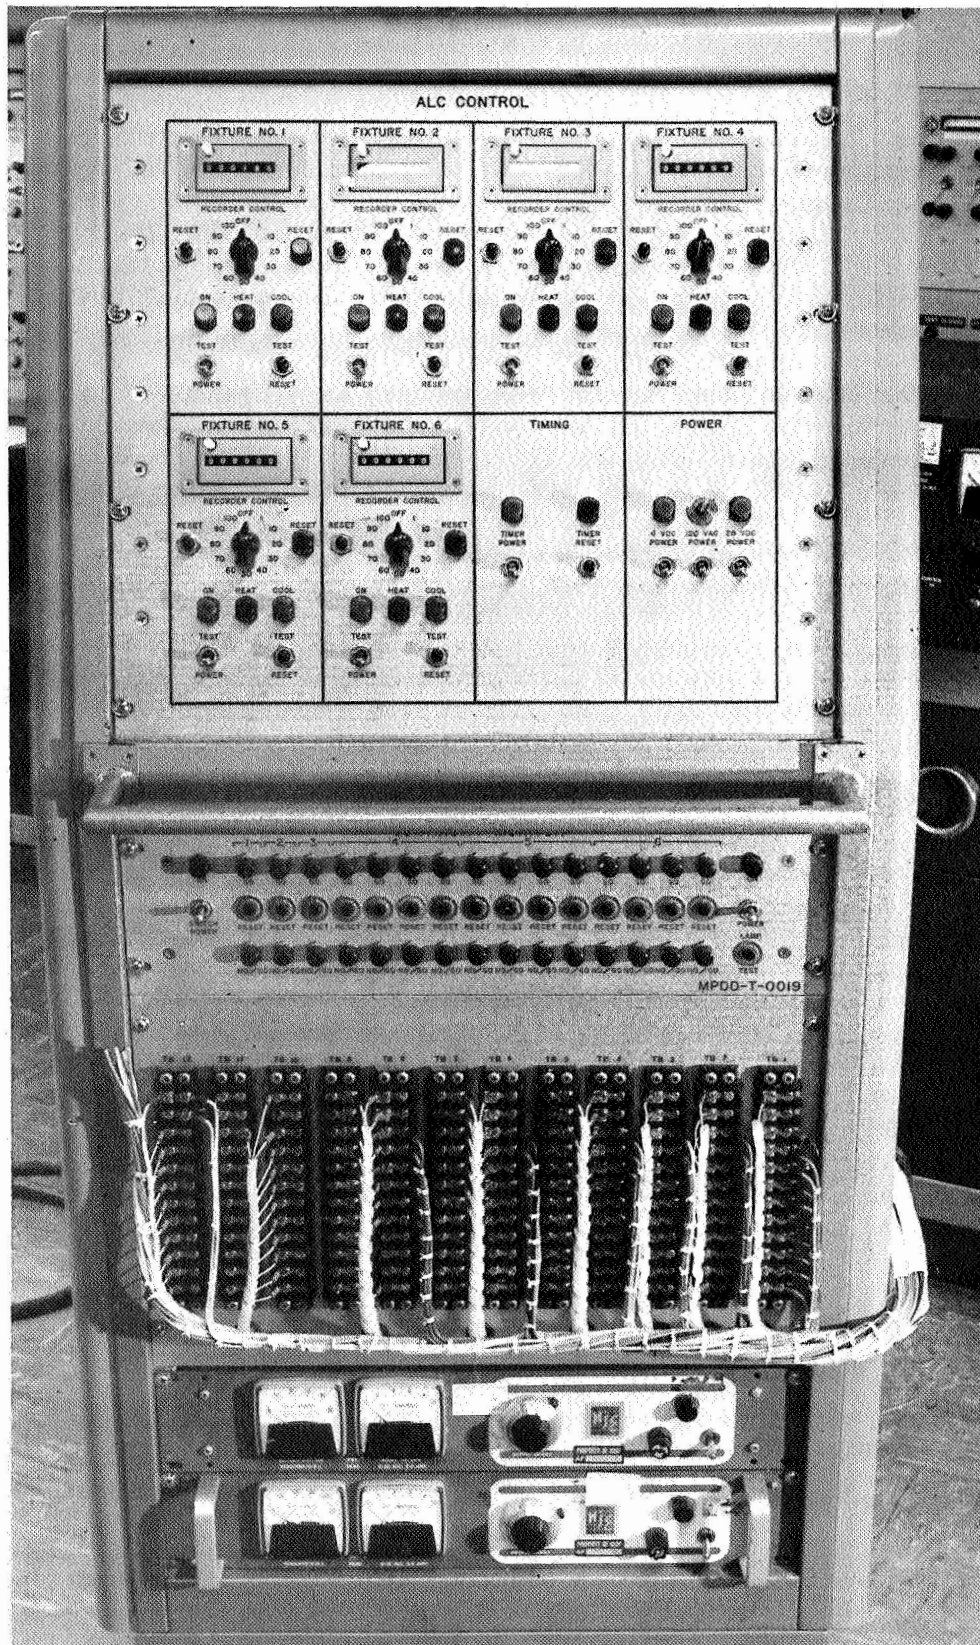
Figure 137.- Thermal Cycling and ALC Control Console

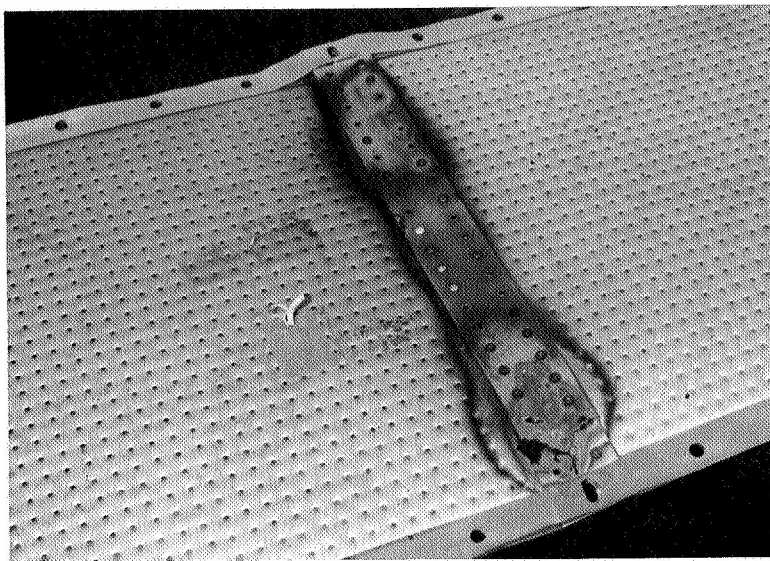
Figure 139.- Top View of Damage to F1A, S/N 0000105

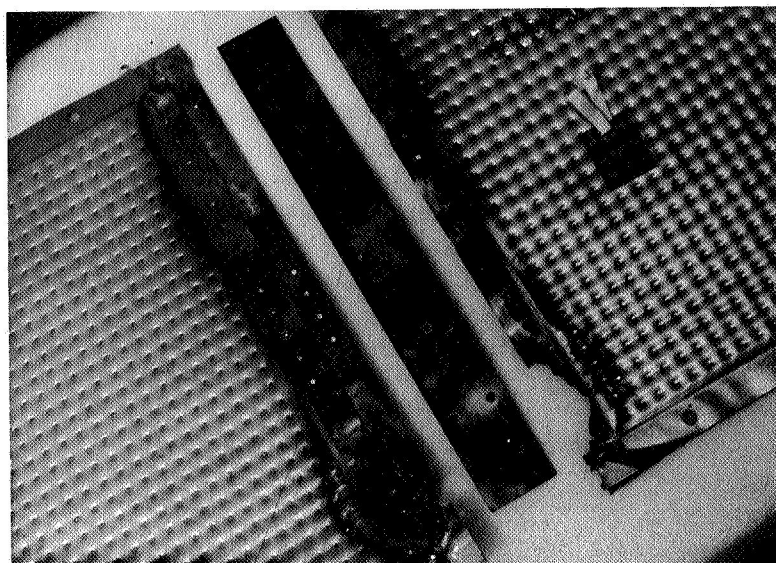
Figure 140.- Bottom View of Overall Splice Area, F1A, S/N 0000105

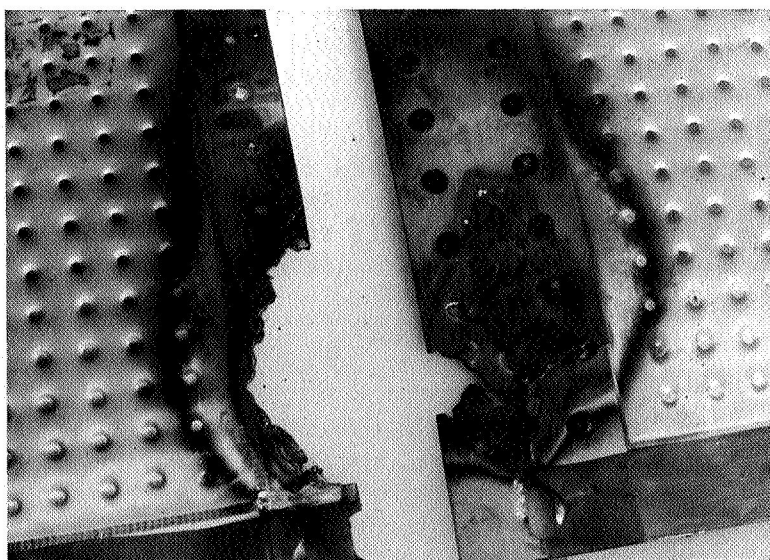
Figure 141.- Closeup of Top View of Damage to F1A, S/N 0000105

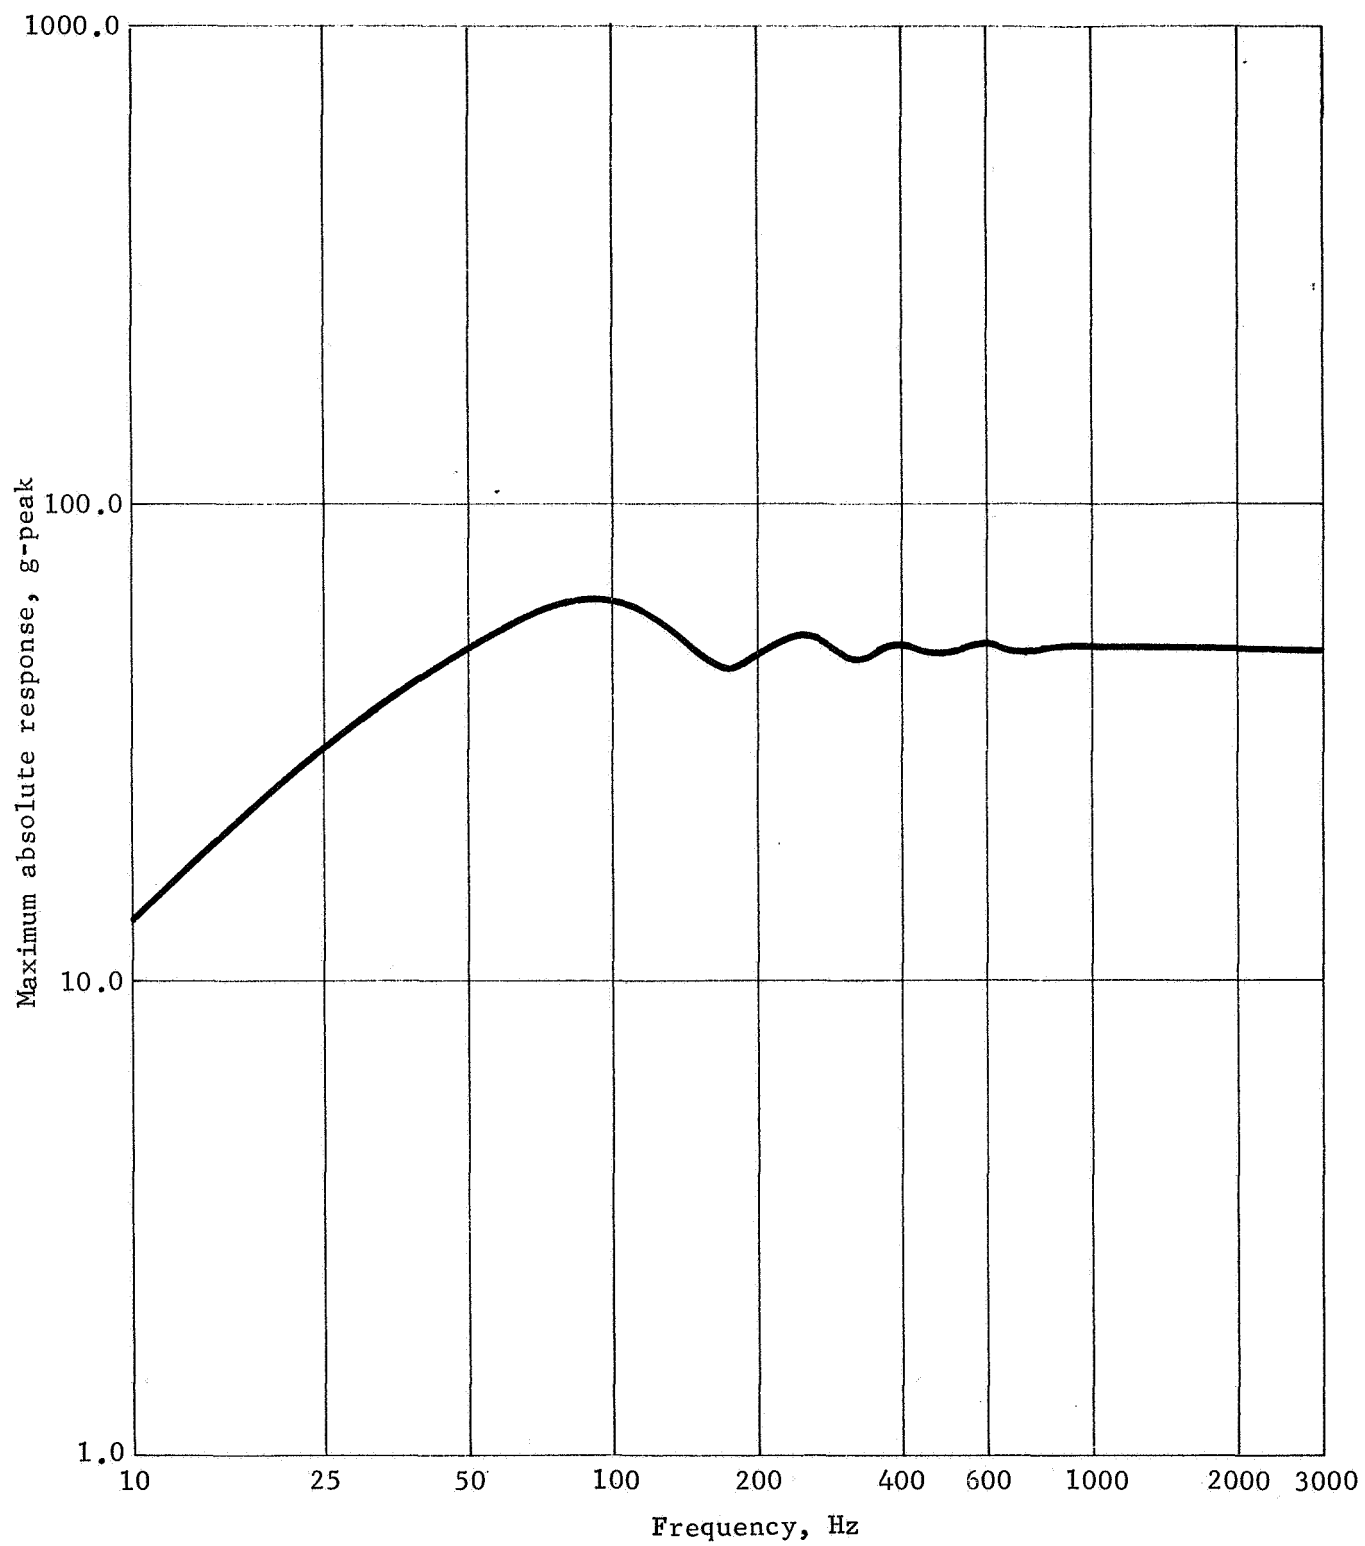
Figure 144.- Shock Response Spectrum, Detector/Panel Qua1

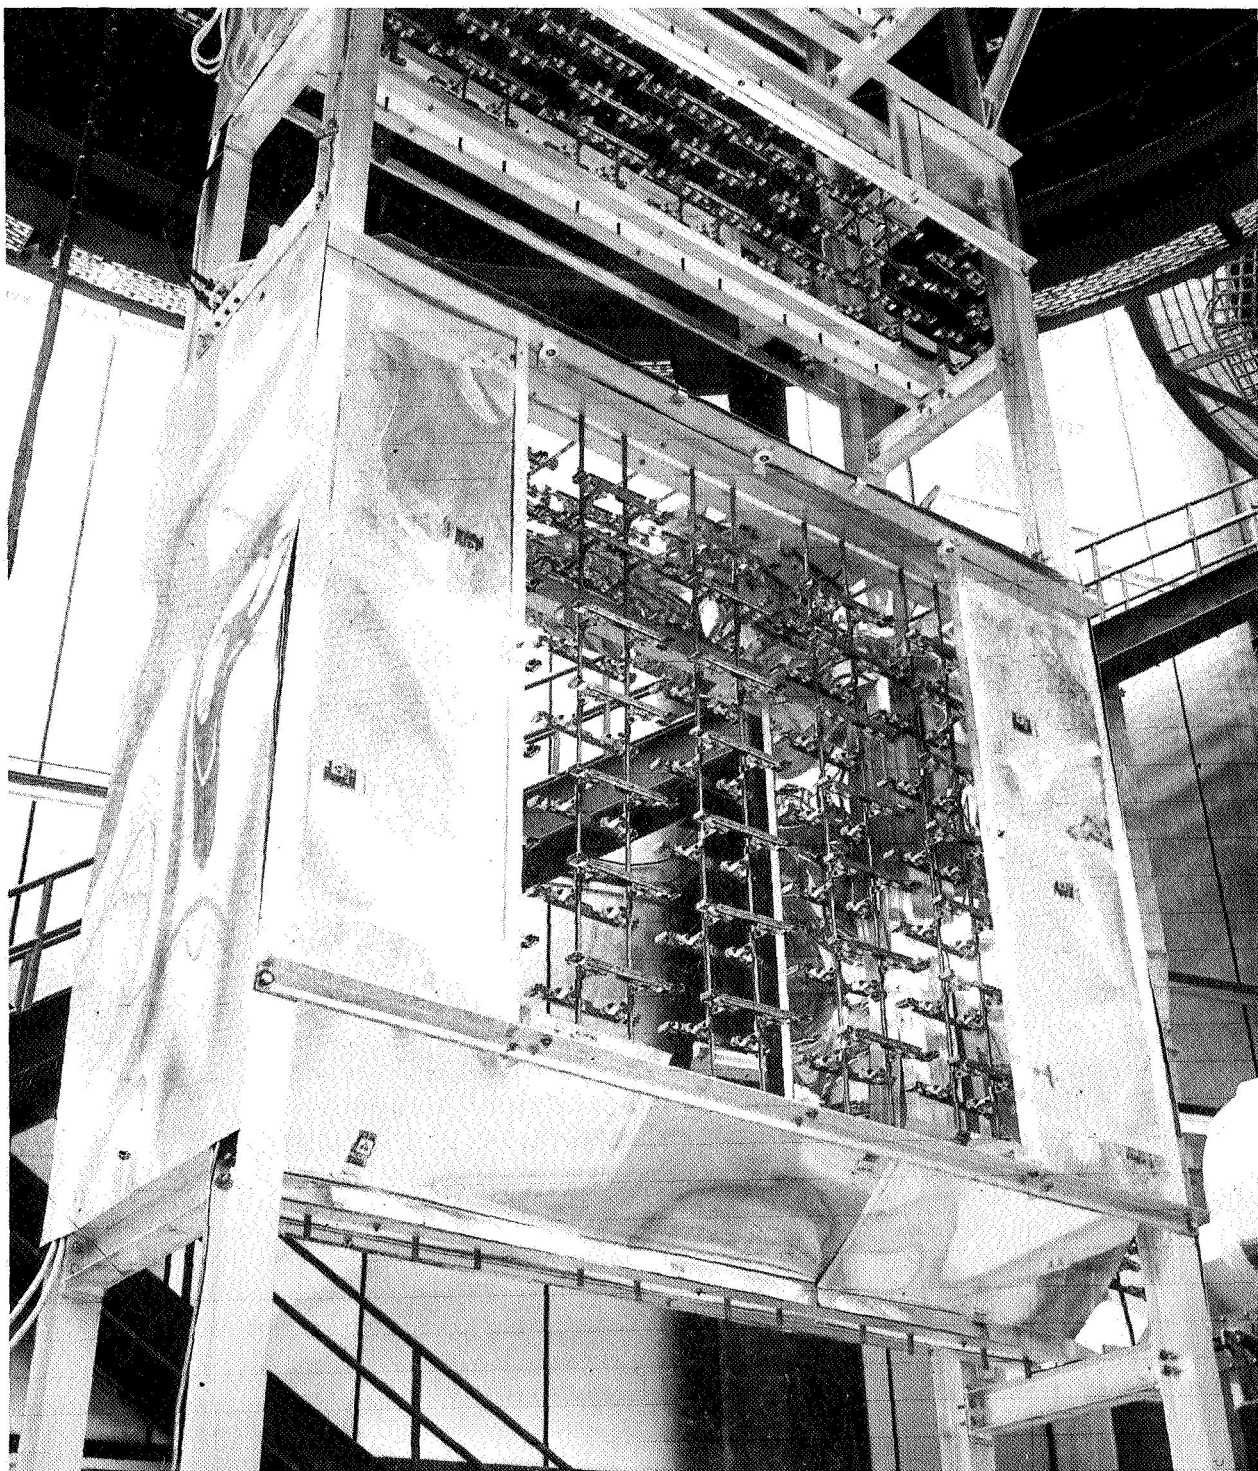
Figure 150.- Infrared Lamp Array for 40x49-in. Detector

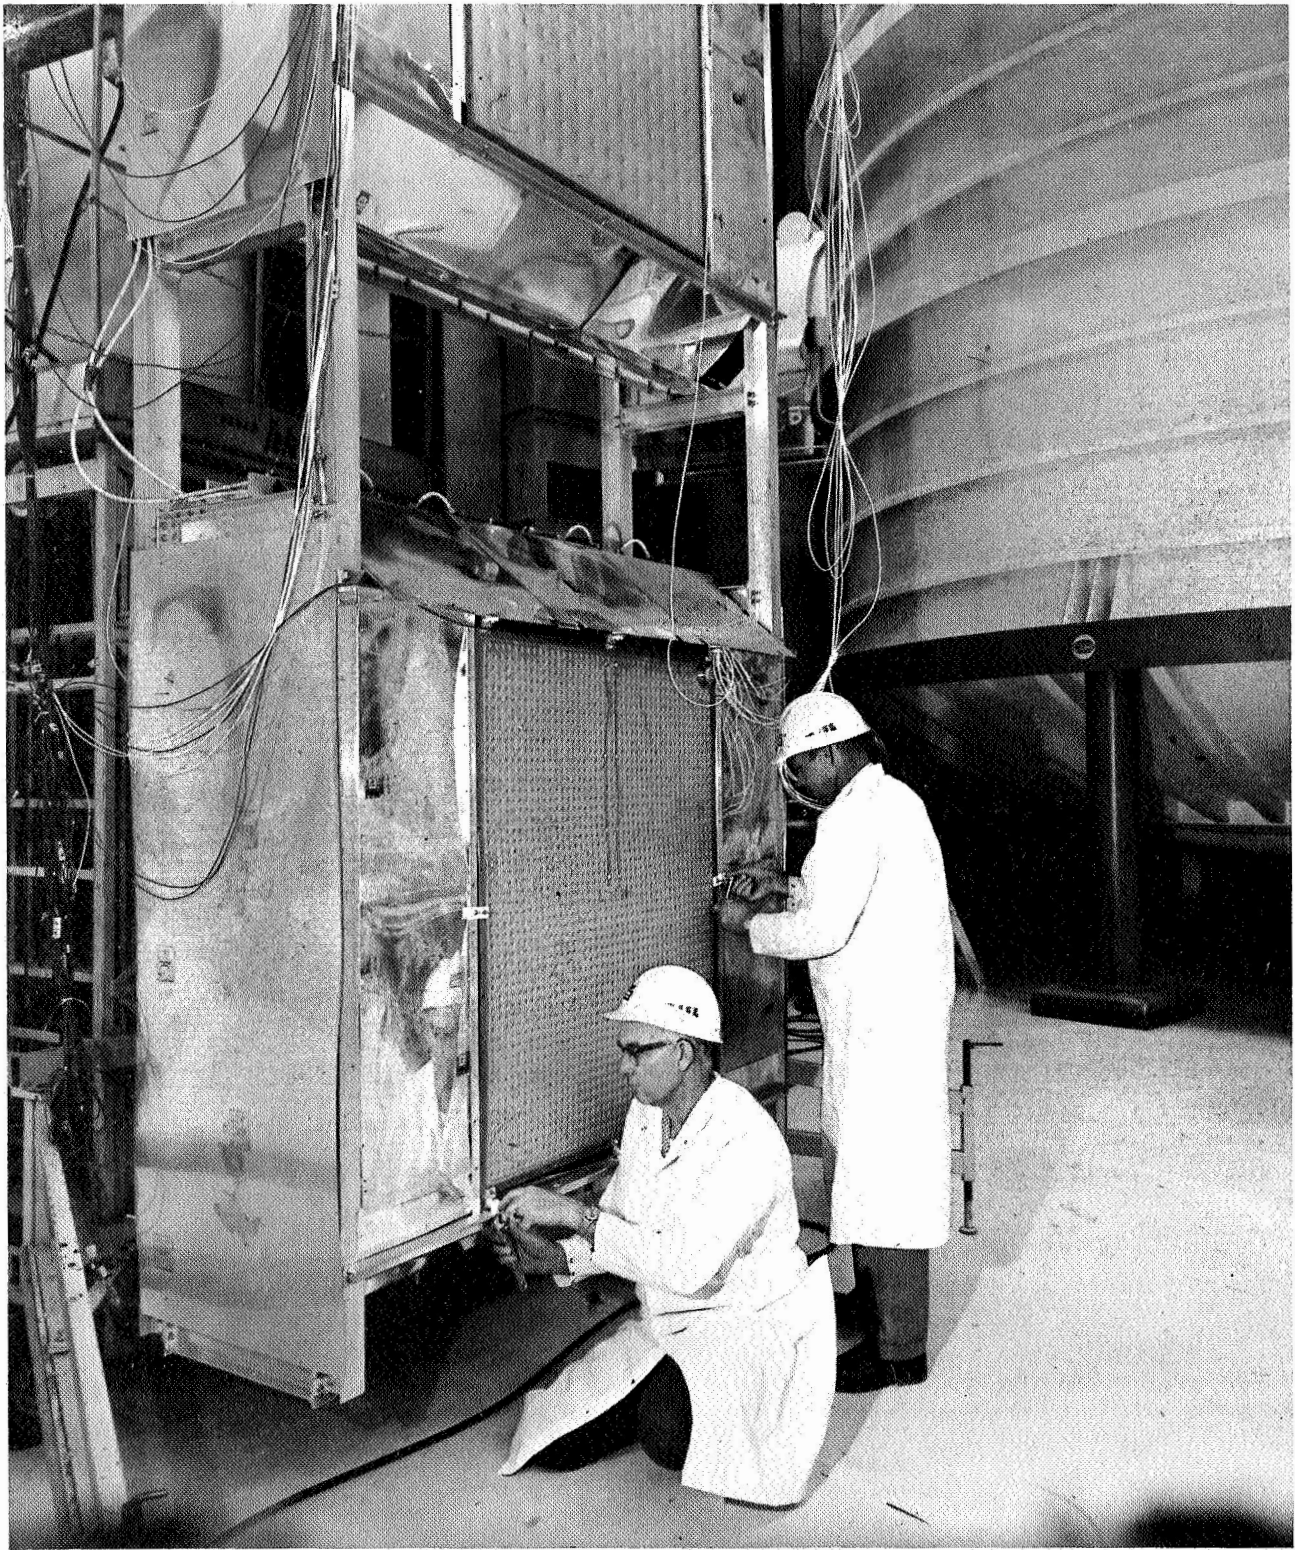
Figure 152.- Installation of D2A Dual Detector

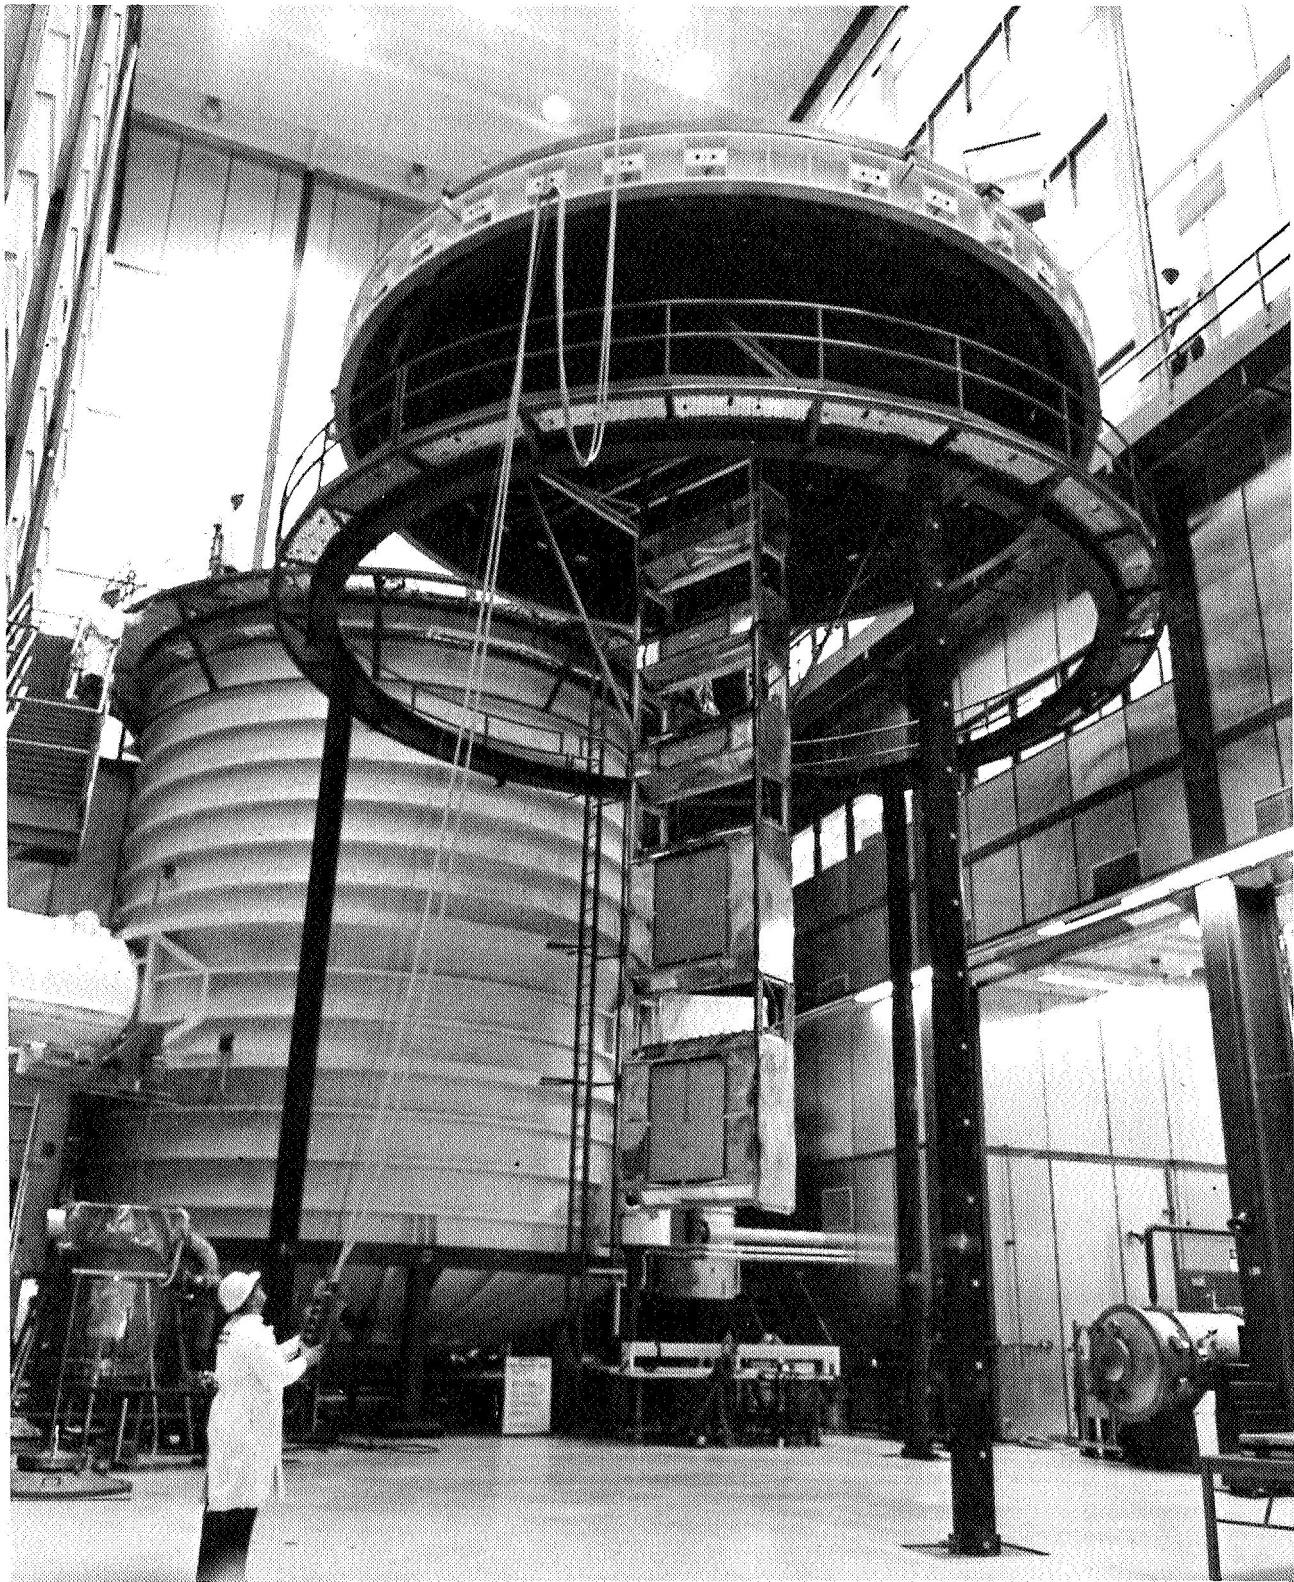
Figure 153.- Test Holding Fixture Shown Suspended from Chamber Lid
